September 23, 2020

City of Kodiak
Office of the Harbor Master
Attn: Michael Sarnowski
710 Mill Bay Road
Kodiak, AK 99615

Subject: **Limited Hazardous Material Survey of Suspect Materials – M/V Wild Alaskan**

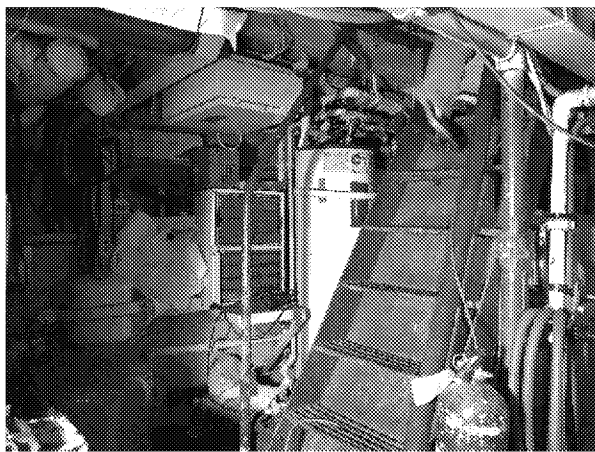
Sample 216, 217	Foyer to Kitchen-Wall, White	Sample 240	Stairs from Pilot to Deck, Blue Handrail
Sample 241	Stairs from Pilot to Deck, Blue Trim	Sample 242, 287, 288	Stairs from Pilot to Deck, Blue Wall, and Exhaust Hood
Sample 238, 249	Stairs-Pilot, Red and Black and White Walls	Sample 250	Engine Room Stairs, White Wall

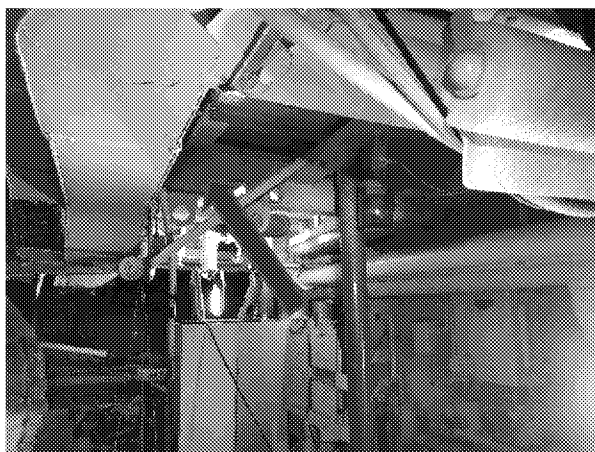
Sample 253,255	Engine Room Stairs, Red Stairs	Sample 213-215	Hydraulic Control Room

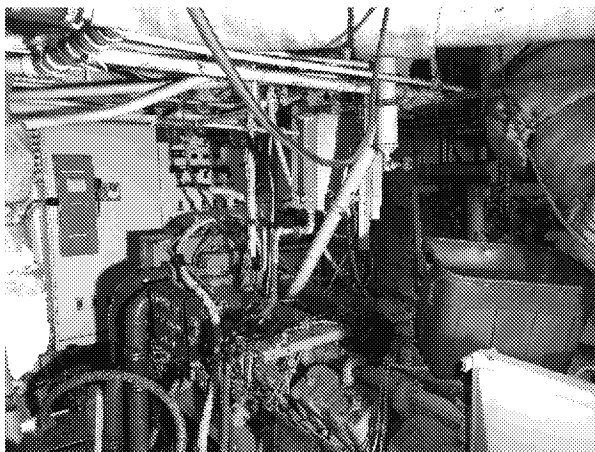
Sample 257,259,	Engine Room, White on Structural Components	Sample 260,261, 276	Engine Room, White on Structural Components, Bulkhead

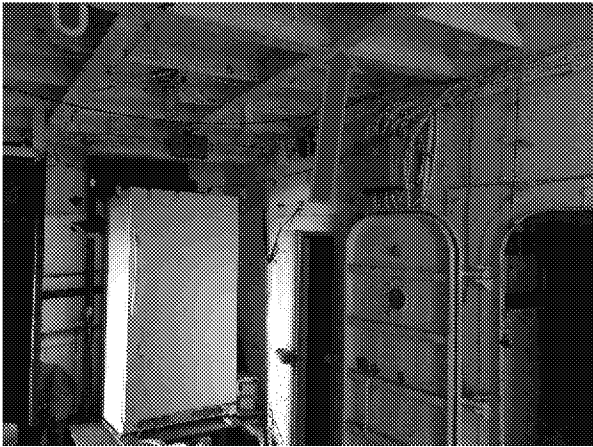
Sample 265,266	Engine Block - Exhaust Assembly, Yellow	Sample 270,273	Engine Room, White Pipe Valve Flange
